# **Fatigue failure analysis of washing machine top frame under cyclic loading – an investigative study in mitigating market complaint**

Memoria Investigaciones en Ingeniería, núm. 27 (2024). pp. 145-160  
<https://doi.org/10.36561/ING.27.10>

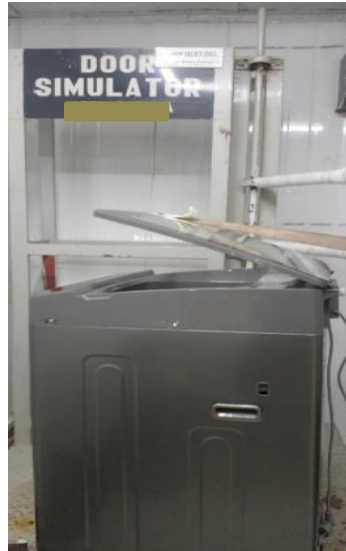
Figure I. Door Simulator (open/close) machine

**3.1.1. Machine.** - A custom-built door simulator machine was used in order to simulate the market condition in which washing machine was open/closed and is shown in figure 1.

Owing to the expenses linked with redesigning, two top frames were produced and put through testing on a door simulator machine, as figure 1 shows. The first top frame was made of ABS (Injection molding grade), which was used for production, and it was first installed on a washing machine. Next, the door simulator machine's open/close

test was started. After 297 cycles, the top frame failed at the hinge interface area. The same testing process was then used to a second top frame made of PC with 50% long glass fiber. A crack developed at the hinge interface location of this top frame just after 3647 cycles.

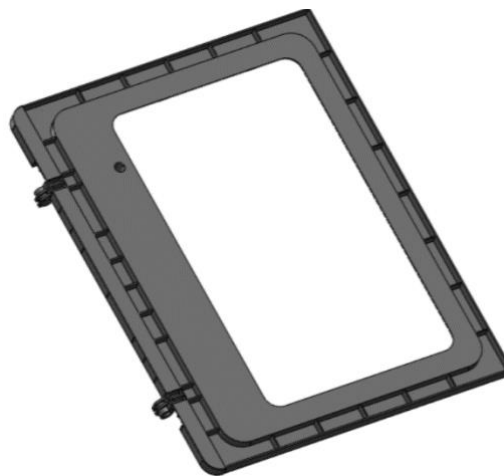
Figure II. Isometric view of top frame.

**4. Design & Analysis of top frame.** - Existing CAD model design of washing machine top frame was made in SolidWorks. Isometric views are available in Fig 2 & Fig 3
